REPORT NUMBER: 10787780COQ-001
ORIGINAL ISSUE DATE: September 30, 2014

PRODUCT EVALUATED:
STEEL DOOR IN PAIRS WITH GLAZED APERTURES

EVALUATION PROPERTY: Air Leakage

Report of steel door in pairs with glazed apertures for the requirements of UL 1784, Air Leakage Tests of Door Assemblies – July 10, 2009.

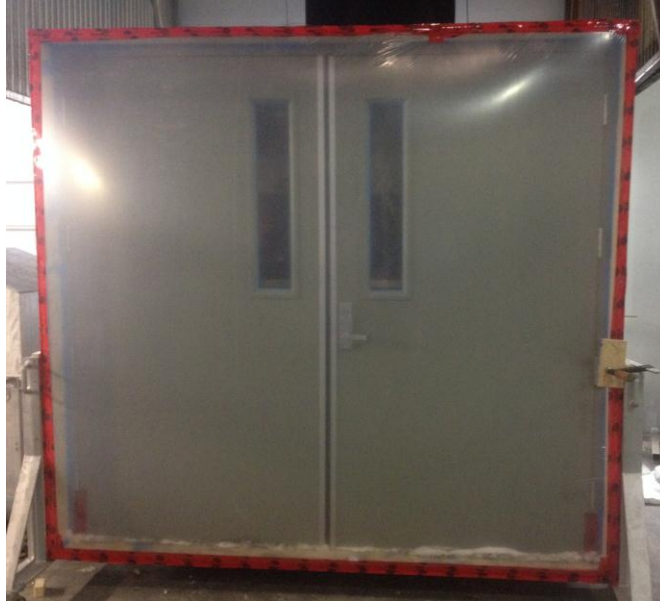
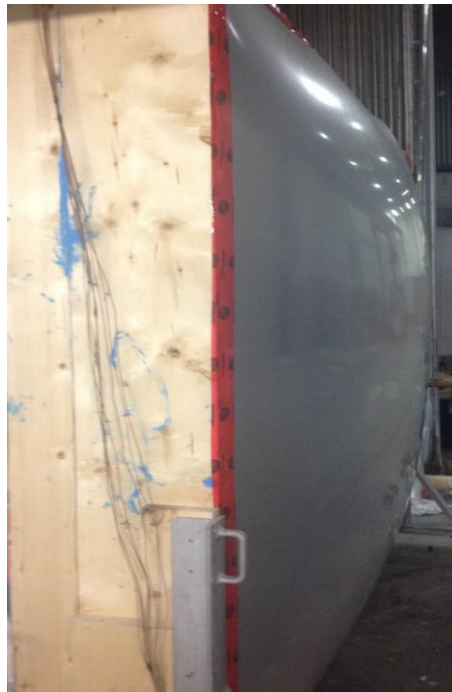
APPENDIX B Photos

The test sample during the air leakage tests.
(the sample was tested in the opposite direction after the first air leakage test cycle was complete)

Air leakage was conducted in accordance with Section 7 of UL 1784. The product was installed into a test chamber consisting of a sealed chamber with one open side in which the test sample is installed and sealed. A pressure tap was provided to measure the chamber pressure. An artificial seal was applied to the ungasketed bottom gap of the test sample.
